Physical Habitat Dynamics in Four Side-channel Chutes, Lower Missouri River

By Robert B. Jacobson, Harold E. Johnson, Mark S. Lastrup, Gary J. D'Urso, and Joanna M. Reuter

Open-File Report 2004-1071

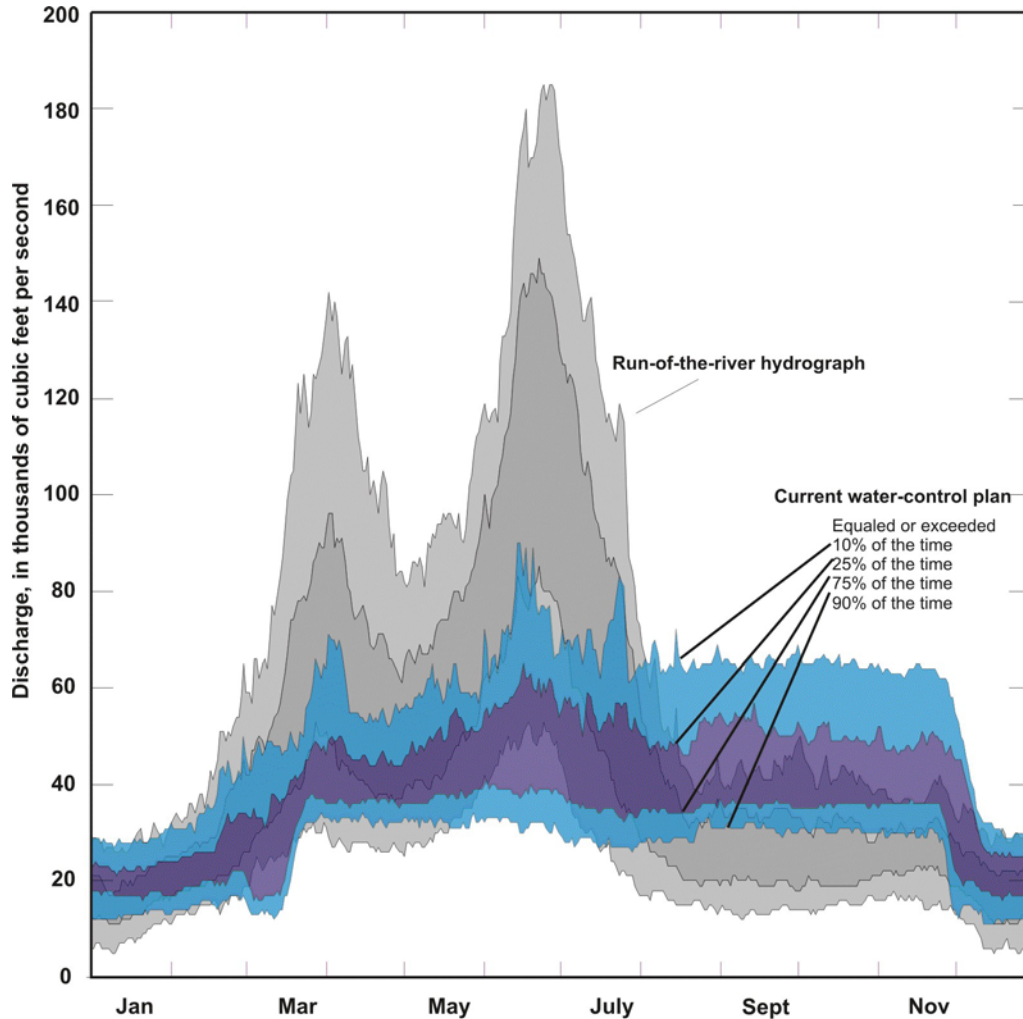
Figure 3. Duration hydrographs constructed using 100 years of simulated daily flows for the Missouri River at Nebraska City, Nebraska, approximately 10 km upstream of Hamburg Bend chute. Methods are documented in Jacobson and Heuser (2002). Gray shades depict the natural hydrograph estimated by a run-of-the-river model. Blue shades depict the regulated hydrograph simulated under the current water control plan (CWCP). Regulation has resulted in substantial decreases in spring flows and increases in late-summer, autumn flows.

The hydrology of the Hamburg Bend Chute can be assessed by using the nearby streamflow-gaging station 10 km upstream at Nebraska City, Nebraska (U.S. Geological Survey streamflow-gaging station 06807000, fig. 1). This streamgage was included in the U.S. Army Corps of Engineers daily routing model (U.S. Army Corps of Engineers, 1998a; Jacobson and Heuser, 2002) so modeled daily discharges are available for the gage for 100 years of record under unregulated and regulated flow conditions (fig. 3). Regulation of the Missouri River at this location has resulted in a substantial decrease in spring flood discharges and increases in summer-fall discharges, July – November.

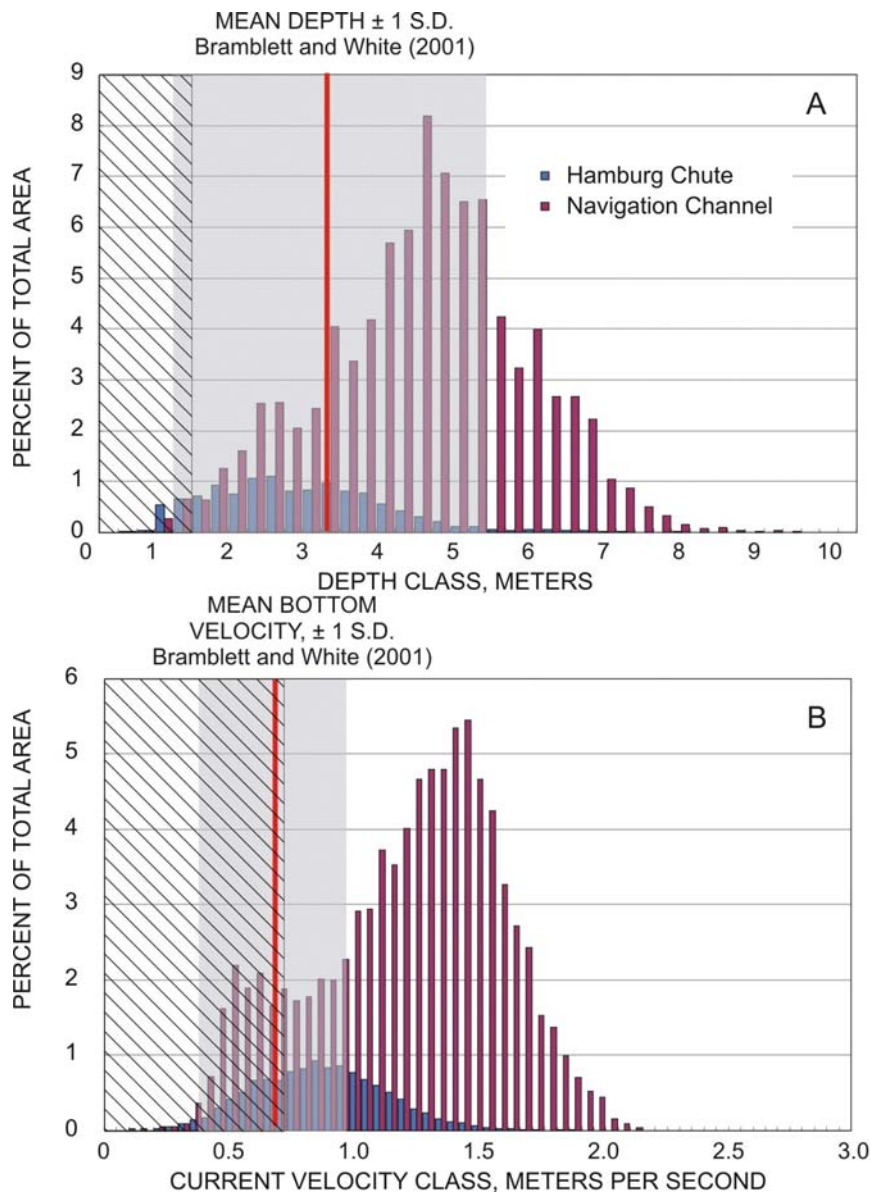
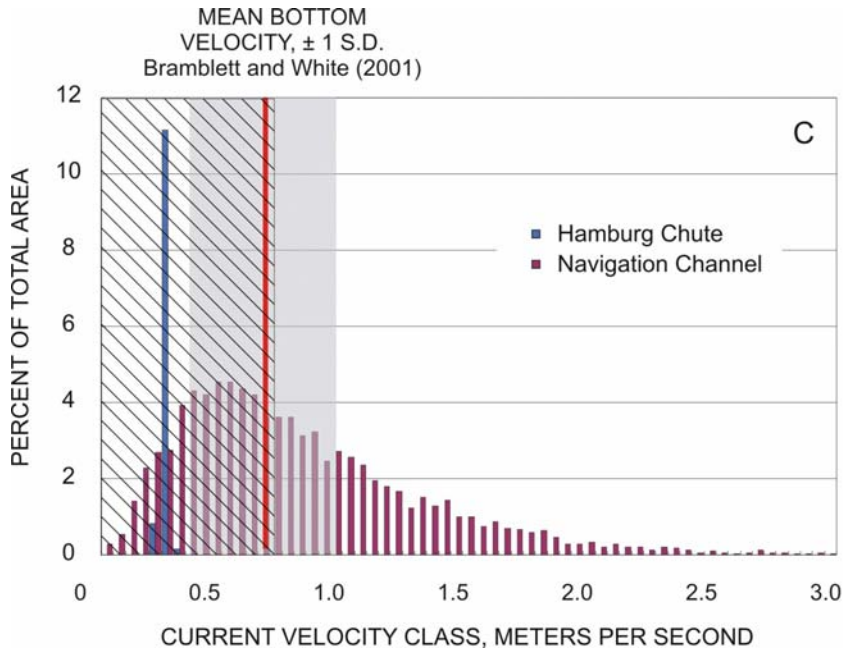
Figure 5. Histograms of depths and velocities measured in the Hamburg Chute and adjacent navigation channel at 37,000 cfs, approximately 63% exceedance. A. Depths. For comparison, mean depth (red line) and standard deviation (S.D., gray box) of pallid sturgeon locations recorded by Bramblett and White (2001) in the upper Missouri River. Depth range of the shallow-water habitat class defined by the U.S. Fish and Wildlife Service (U.S. Fish and Wildlife Service, 2000) is shown for comparison in the cross-hatched box. B. Depth-averaged velocities. For comparison, mean bottom velocity (red line) and standard deviation (S.D., gray box) of pallid sturgeon locations recorded by Bramblett and White (2001) in the upper Missouri River. Velocity range of the shallow-water habitat class defined by the U.S. Fish and Wildlife Service (U.S. Fish and Wildlife Service, 2000) is shown for comparison in the cross-hatched box.

Figure 5 (cont). Histograms of depths and velocities measured in the Hamburg Chute and adjacent navigation channel at 37,000 cfs, approximately 63% exceedance. C. Bottom velocities recorded at approximately same elevation above bottom as Bramblett and White (2001).

Histograms of depths and velocities were developed to characterize the distributions of these variables in the chute and navigation channel (fig. 5). The histograms are shown as percent of total area of the navigation channel and chute. For both depth and velocity, the navigation channel provides a much wider range of values than the chute, and the range includes all of the values present in the chute. Although most of the navigation channel is relatively fast and deep, areas of shallower, slower water exist on the margins and in association with wing dikes. For comparison, the shaded area in figure 5 shows the mean plus or minus (\pm) one standard deviation of the velocity used by pallid sturgeon on the upper Missouri and Yellowstone rivers (Bramblett and White, 2001). Another measure for comparison is the definition of shallow-water habitat (SWH) identified by the Fish and Wildlife Service (U.S. Fish and Wildlife Service, 2000) as lacking in the Lower Missouri River. SWH was defined as less than 5 ft (1.5 m) deep and less than 2.5 ft/s (1.5 m/s) current velocity. At 37,000 cfs, the Hamburg Bend chute provides additional areas of SWH, and most of the velocities provided are coincident with those used by pallid sturgeon.

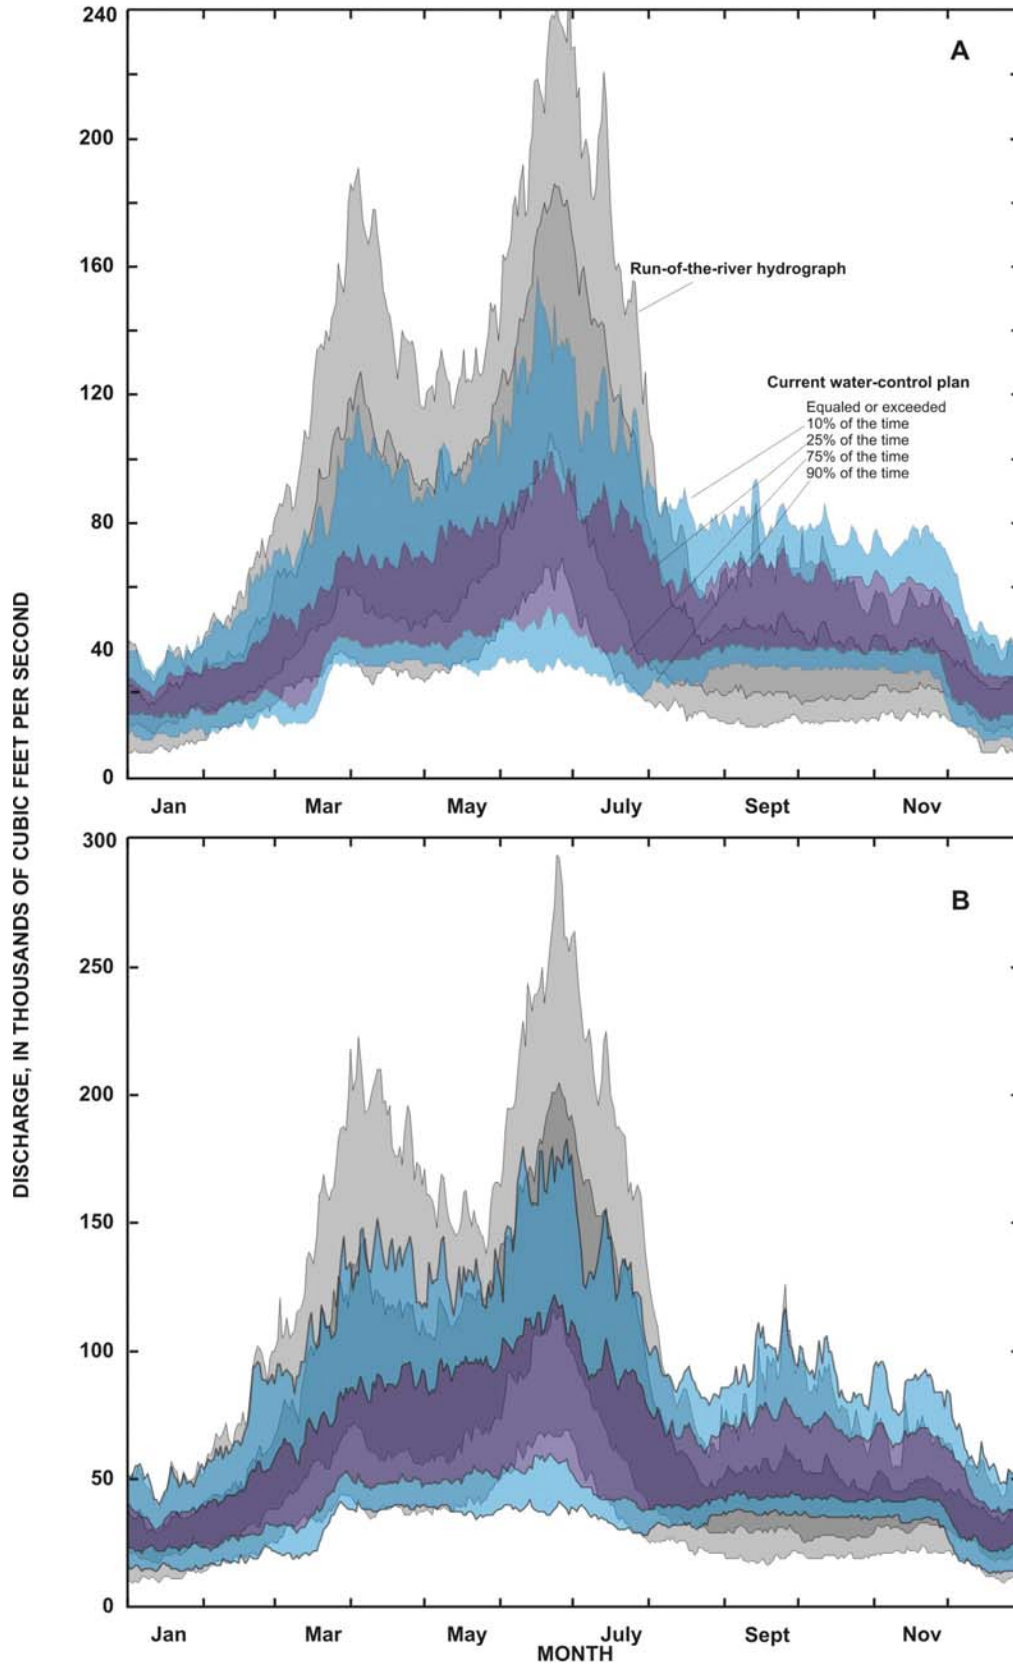
Figure 7. Duration hydrographs constructed using 100 years of simulated daily flows for the Missouri River at A. Kansas City, Missouri, and B. Boonville, Missouri. Gray shades depict the natural hydrograph estimated by a run-of-the-river model. Blue shades depict the regulated hydrograph simulated under the current water control plan (CWCP).

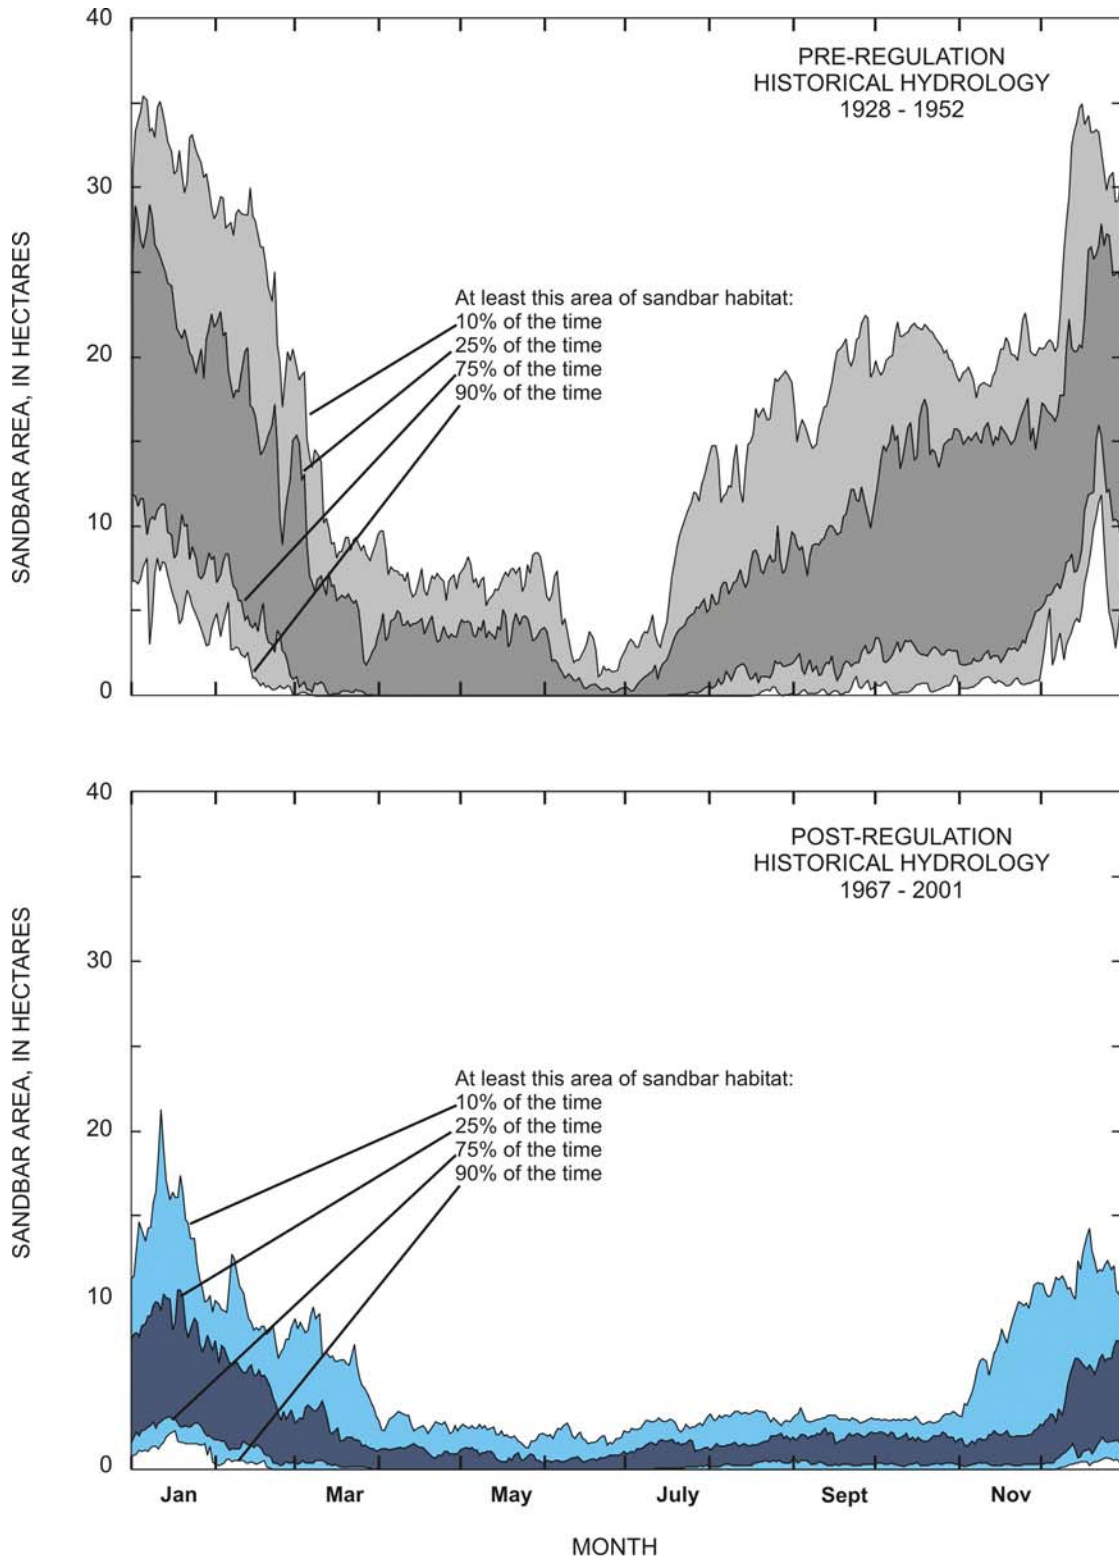
Figure 10. Sandbar area durations for the Cranberry Bend side-channel chute for historical pre- and post-regulation time periods. The graphs depict sandbar areas resulting from discharges that are equaled or exceeded 90, 70, 25, and 10% of the time for each day of the year.

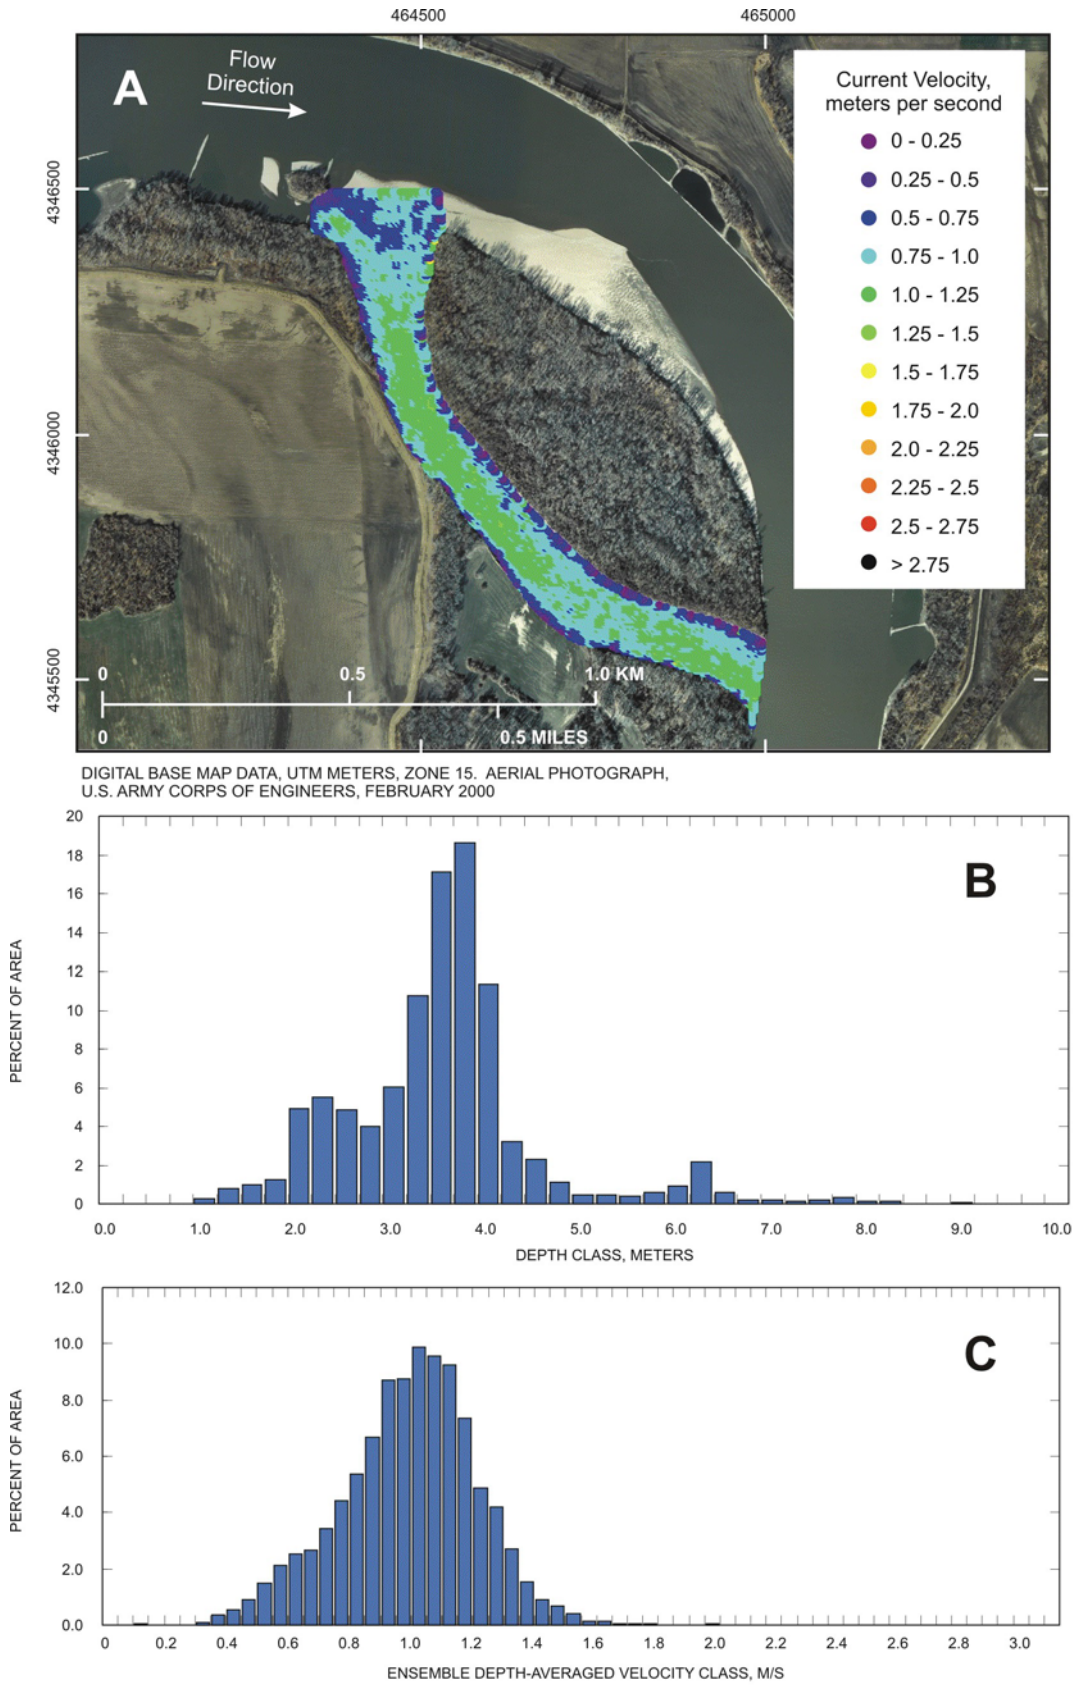
Figure 11. Depth and velocity data from Cranberry Bend chute, measured May 14, 2002. The discharge in the main channel on this date was 95,000 cfs, and approximately 12,000 cfs was flowing through the chute. Aerial photo base is from February 27, 2000, discharge = 39,000 cfs. A. Map of depth-averaged velocity from acoustic Doppler profiler data. B. Histogram of depths in the chute. C. Histogram of velocities in the chute.

A full bathymetric and velocity survey of the chute was completed on May 14, 2002 at a discharge of 95,000 cfs, or 13% flow exceedance. These conditions were favorable for boat access to all parts of the chute. Because this flow is relatively rare, the hydraulic conditions shouldn't be considered representative; nevertheless, histograms of depth and depth-averaged velocity are shown with a map of velocities in figure 11.

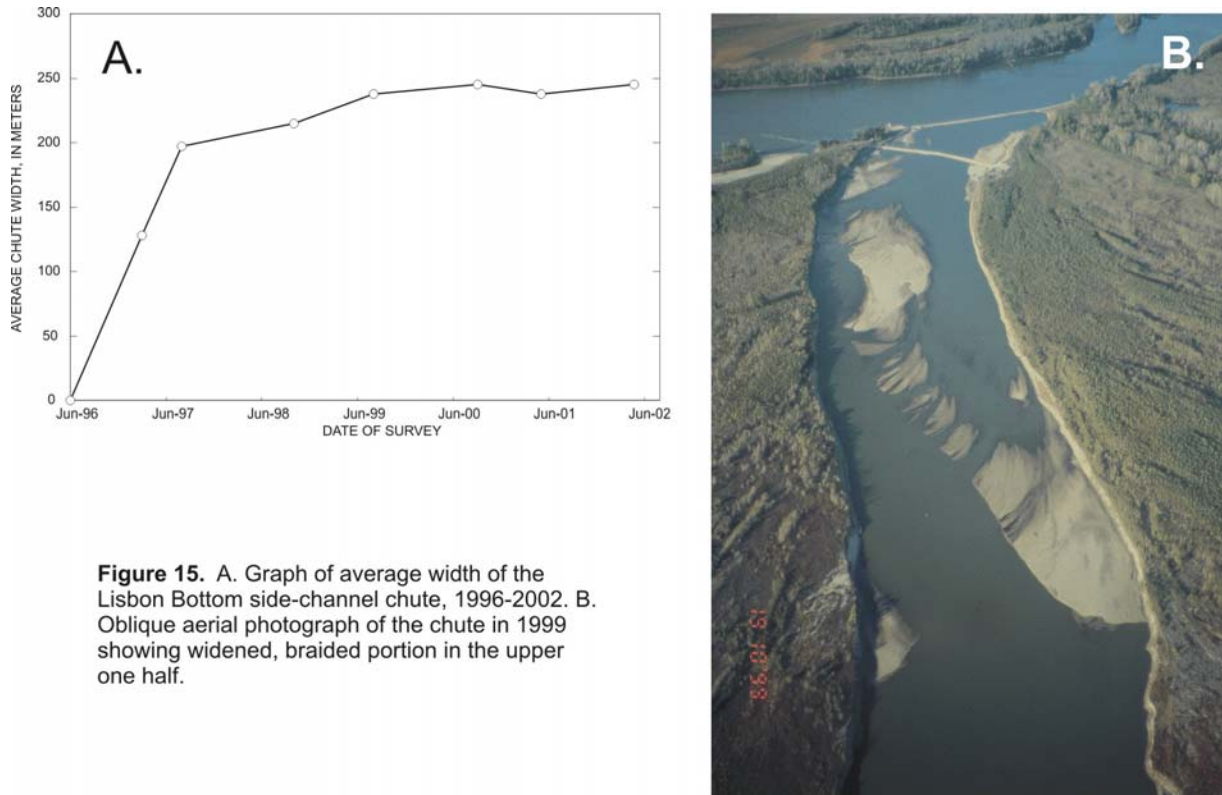
Figure 15. A. Graph of average width of the Lisbon Bottom side-channel chute, 1996-2002. B. Oblique aerial photograph of the chute in 1999 showing widened, braided portion in the upper one half.

The chute widened rapidly 1996 – 1997, followed by a smaller rate of change 1998 - 2002 and achievement of an apparent equilibrium width (fig. 15). During this time the chute developed a planform dominated by a braided channel appearance in the upstream one half and a meandering planform in the downstream one half.

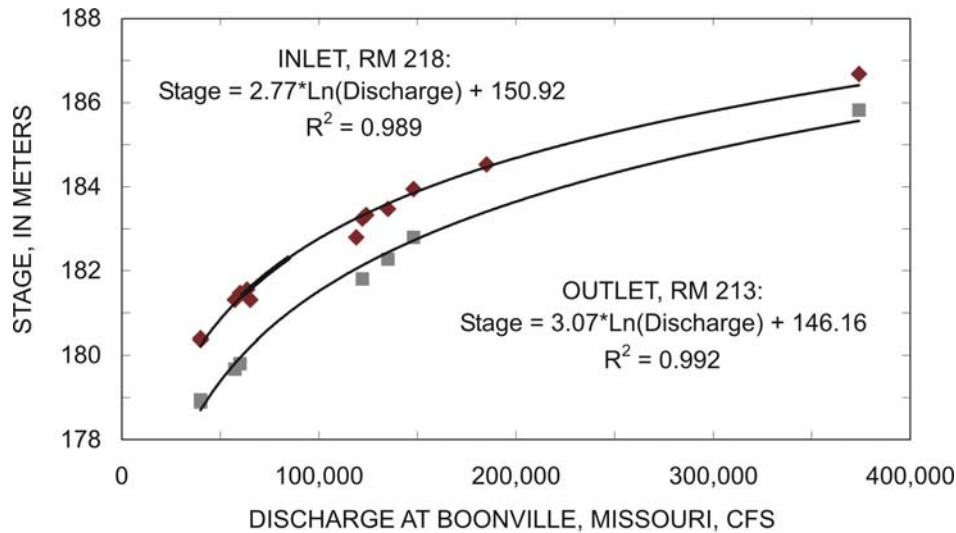
Figure 16. Stage-discharge relations at upstream inlet and downstream outlet of the Lisbon Bottom side-channel chute. Units in equations: stage in meters, discharge in cubic feet per second. RM, river mile.

The hydrology of the chute is controlled by the hydrology of the main channel and the elevations and geometries of the upstream and downstream entrances. The notches in the upstream revetment and control structure were surveyed at 178.87 m on December 10, 2002; evidence of erosion in these notches indicates that these elevations have probably not been static since construction in 2002. Zero flow into the chute from upstream was independently determined by a survey when the elevation of water in the main channel was 179.24 m (24,600 cfs at the Boonville gage, U.S. Geological streamflow-gaging station 06909000); at this water-surface elevation there was a very slight flow of water from the chute back into the main channel. The elevation of the downstream entrance to the chute (outlet, in the center of the thalweg as of April 2002) was determined from bathymetric survey to be about 177.2 m .

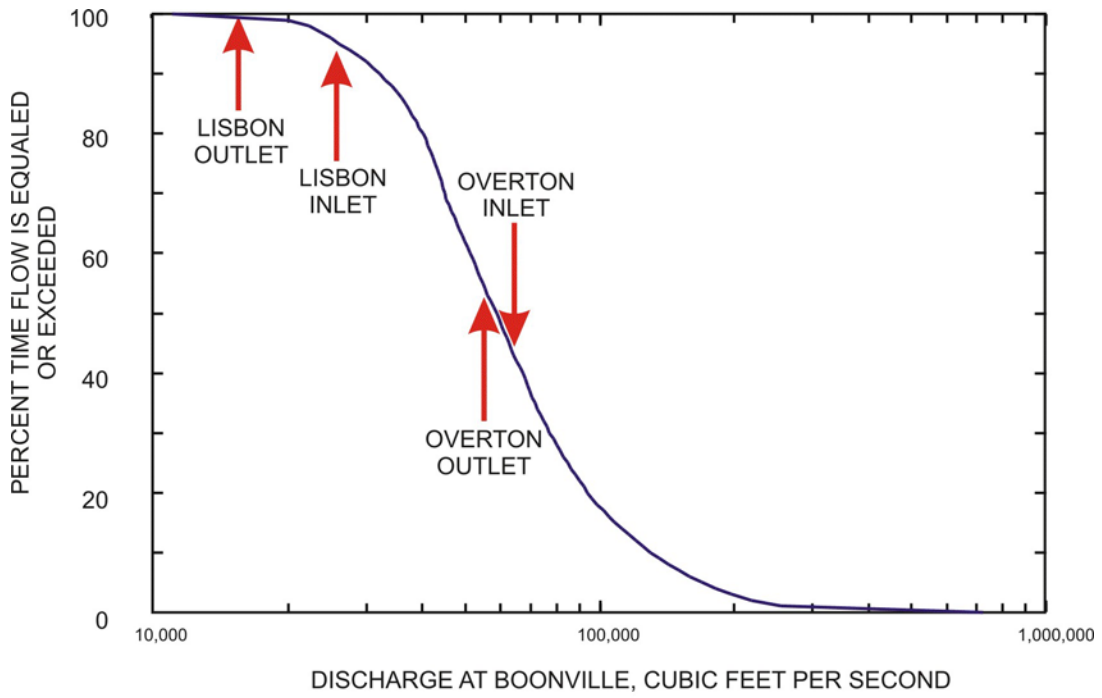
Figure 17. Flow duration of the Missouri River at Boonville and discharges at which flow enters the inlet and outlet of the Lisbon Bottom and Overton Bottoms side-channel chutes.

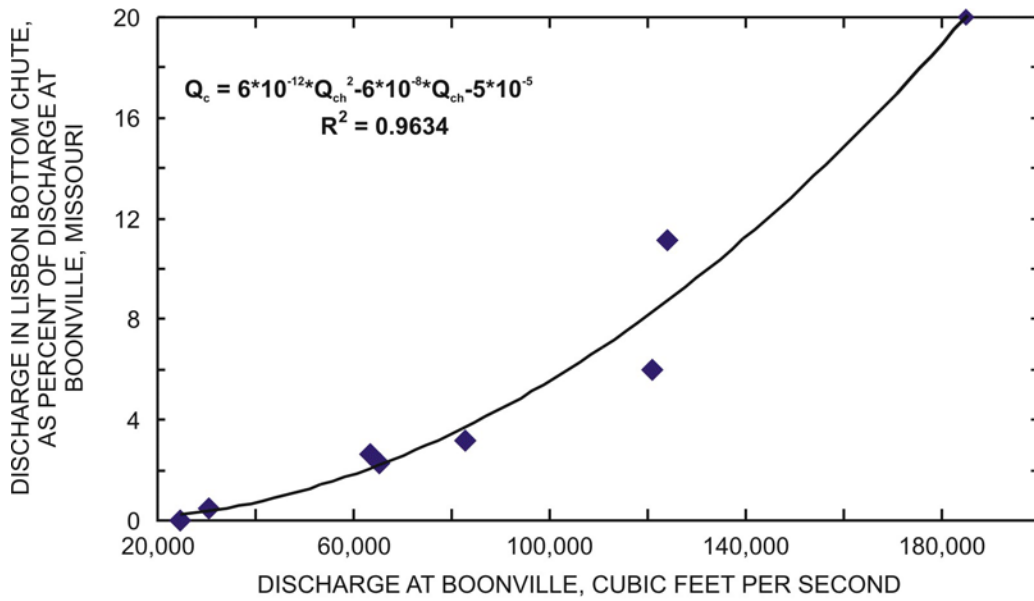
Figure 18. Percent flow in Lisbon Bottom side-channel chute compared to discharge in main channel as measured at Boonville, Missouri. Q_c , discharge in chute; Q_{ch} , discharge in main channel at Boonville, Missouri.

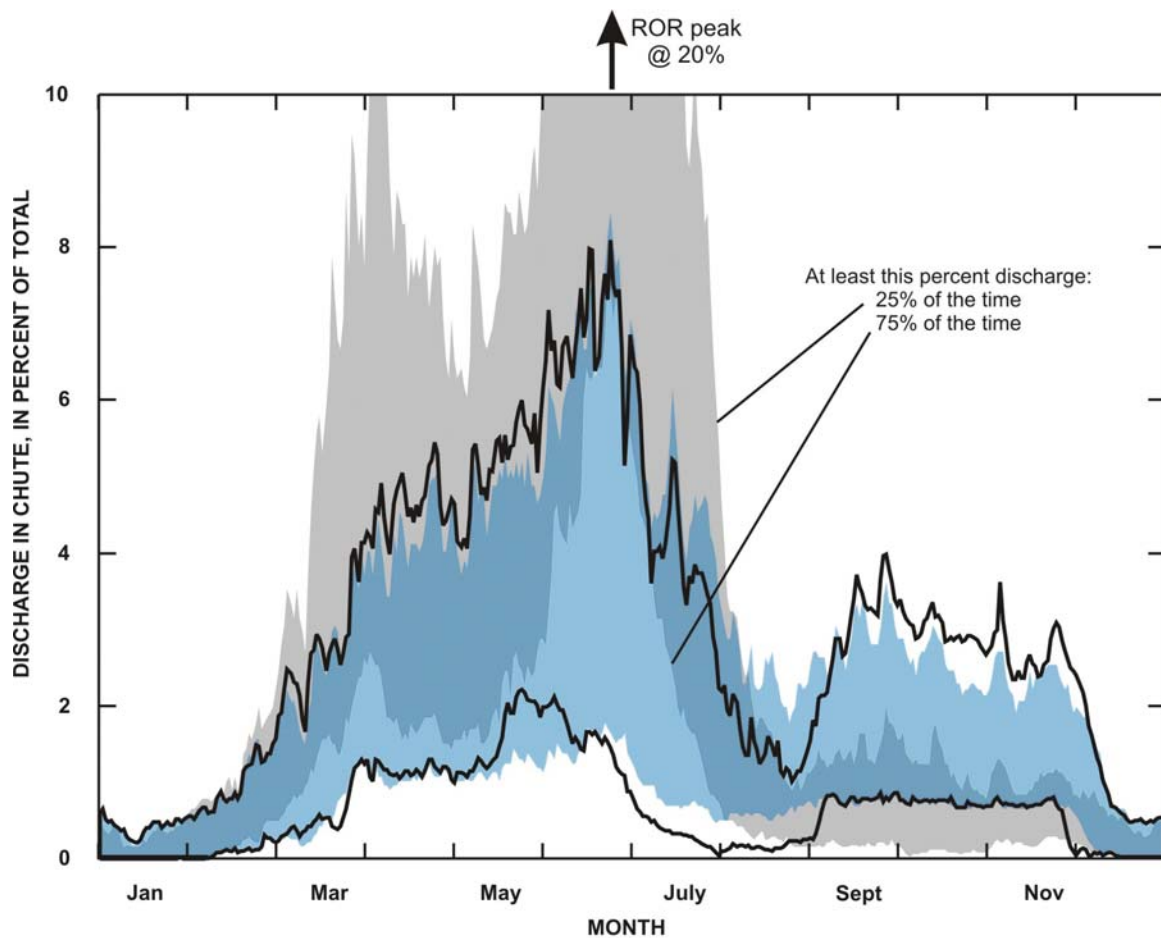
Figure 19. Duration hydrographs for percentage flow in the Lisbon Bottom side-channel chute. The gray shaded background is the 25-75% exceedance flows for the natural (ROR) hydrograph; the dark black lines depict the 25-75% exceedances of the GP2021 alternative, and the blue shaded areas depict the 25-75% exceedances of the current water control plan.

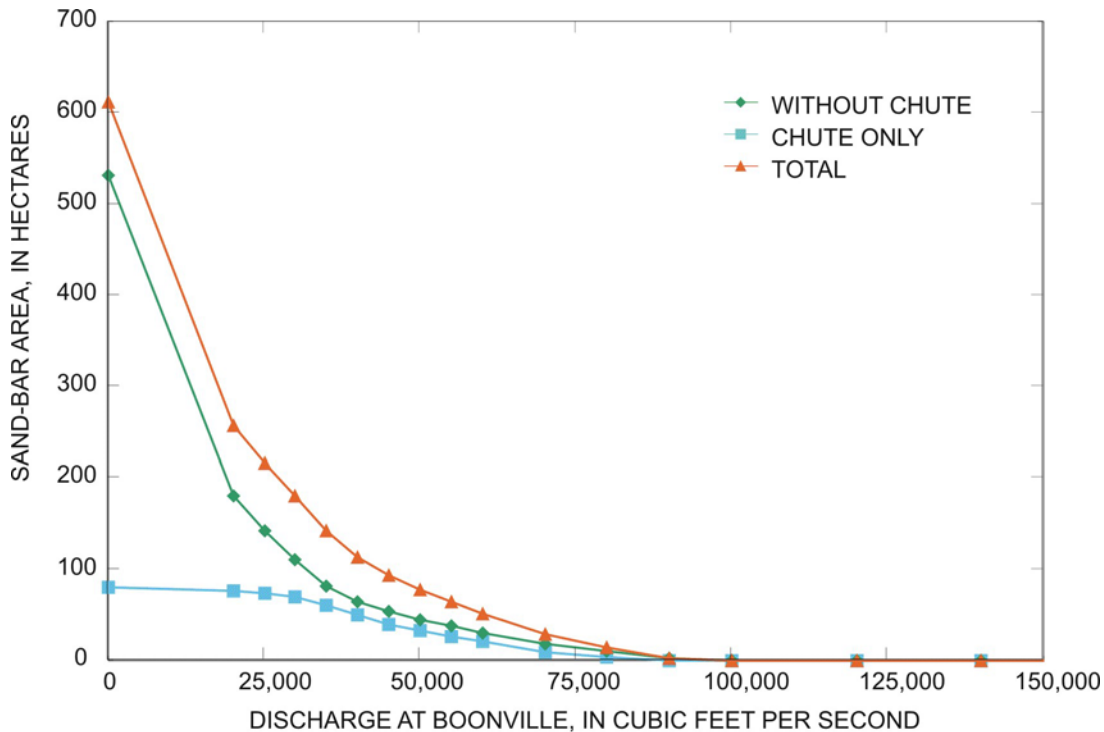
Figure 24. Sand-bar area and discharge, Lisbon Bottom side-channel chute and adjacent area. Calculated from 1-dimensional hydraulic model of the Lisbon-Jameson reach.

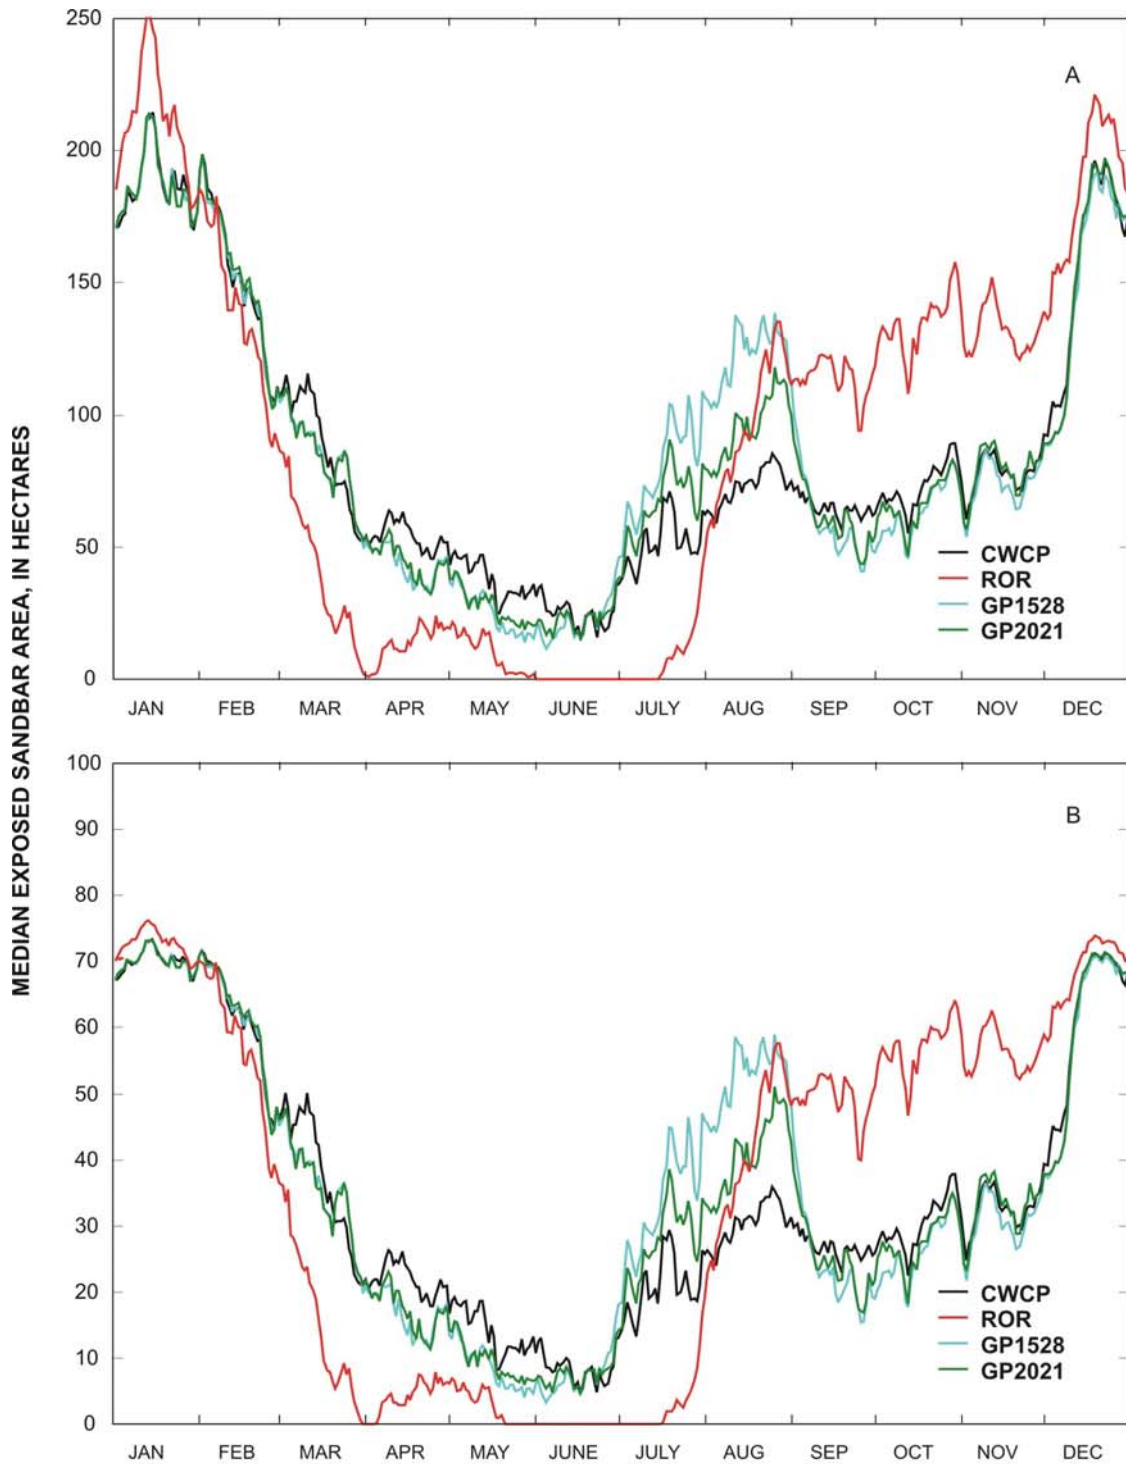
Figure 25. Exposed sandbar availability at Lisbon Bottom side-channel chute, calculated from 1-dimensional hydraulic model, by time of year and by discharge scenario. A. Median of 100 years of daily sandbar availability for entire modeled area. B. Median of 100 years of daily sandbar availability within the banks of the chute. CWCP, current water-control plan; ROR, run of the river model; GP1528, flow scenario with 15,000 cfs spring rise and 28,000 cfs summer low flow; GP2021, flow scenario with 20,000 cfs spring rise and 21,000 cfs summer low flow.

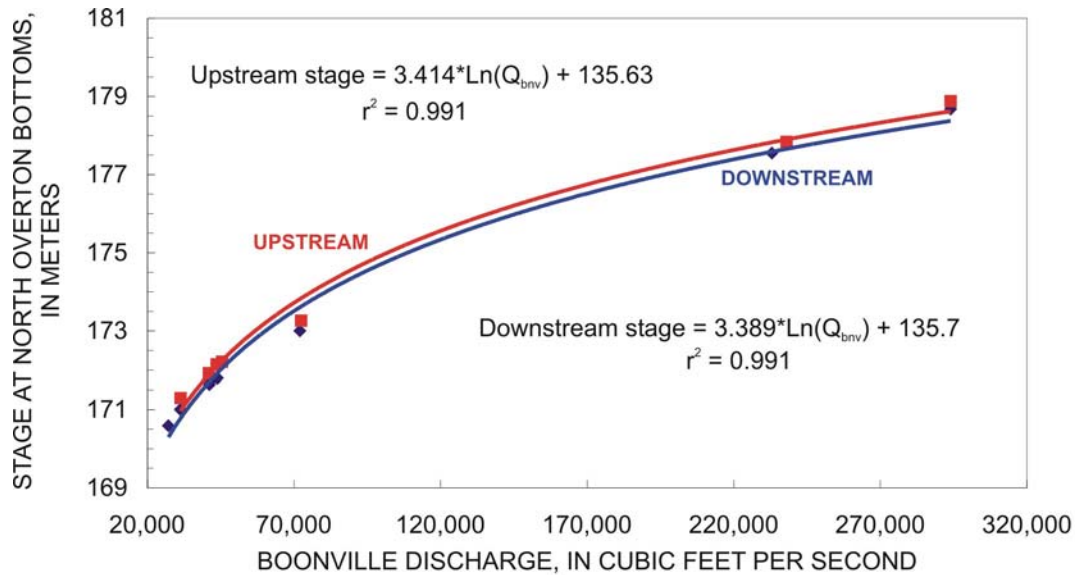
Figure 30. Stage-discharge relations surveyed for the original inlet and outlet, North Overton Bottoms side-channel chute. The relations are fitted to logarithmic functions. Stage is in meters; Q_{bnv} , discharge at Boonville, Missouri in cubic feet per second..

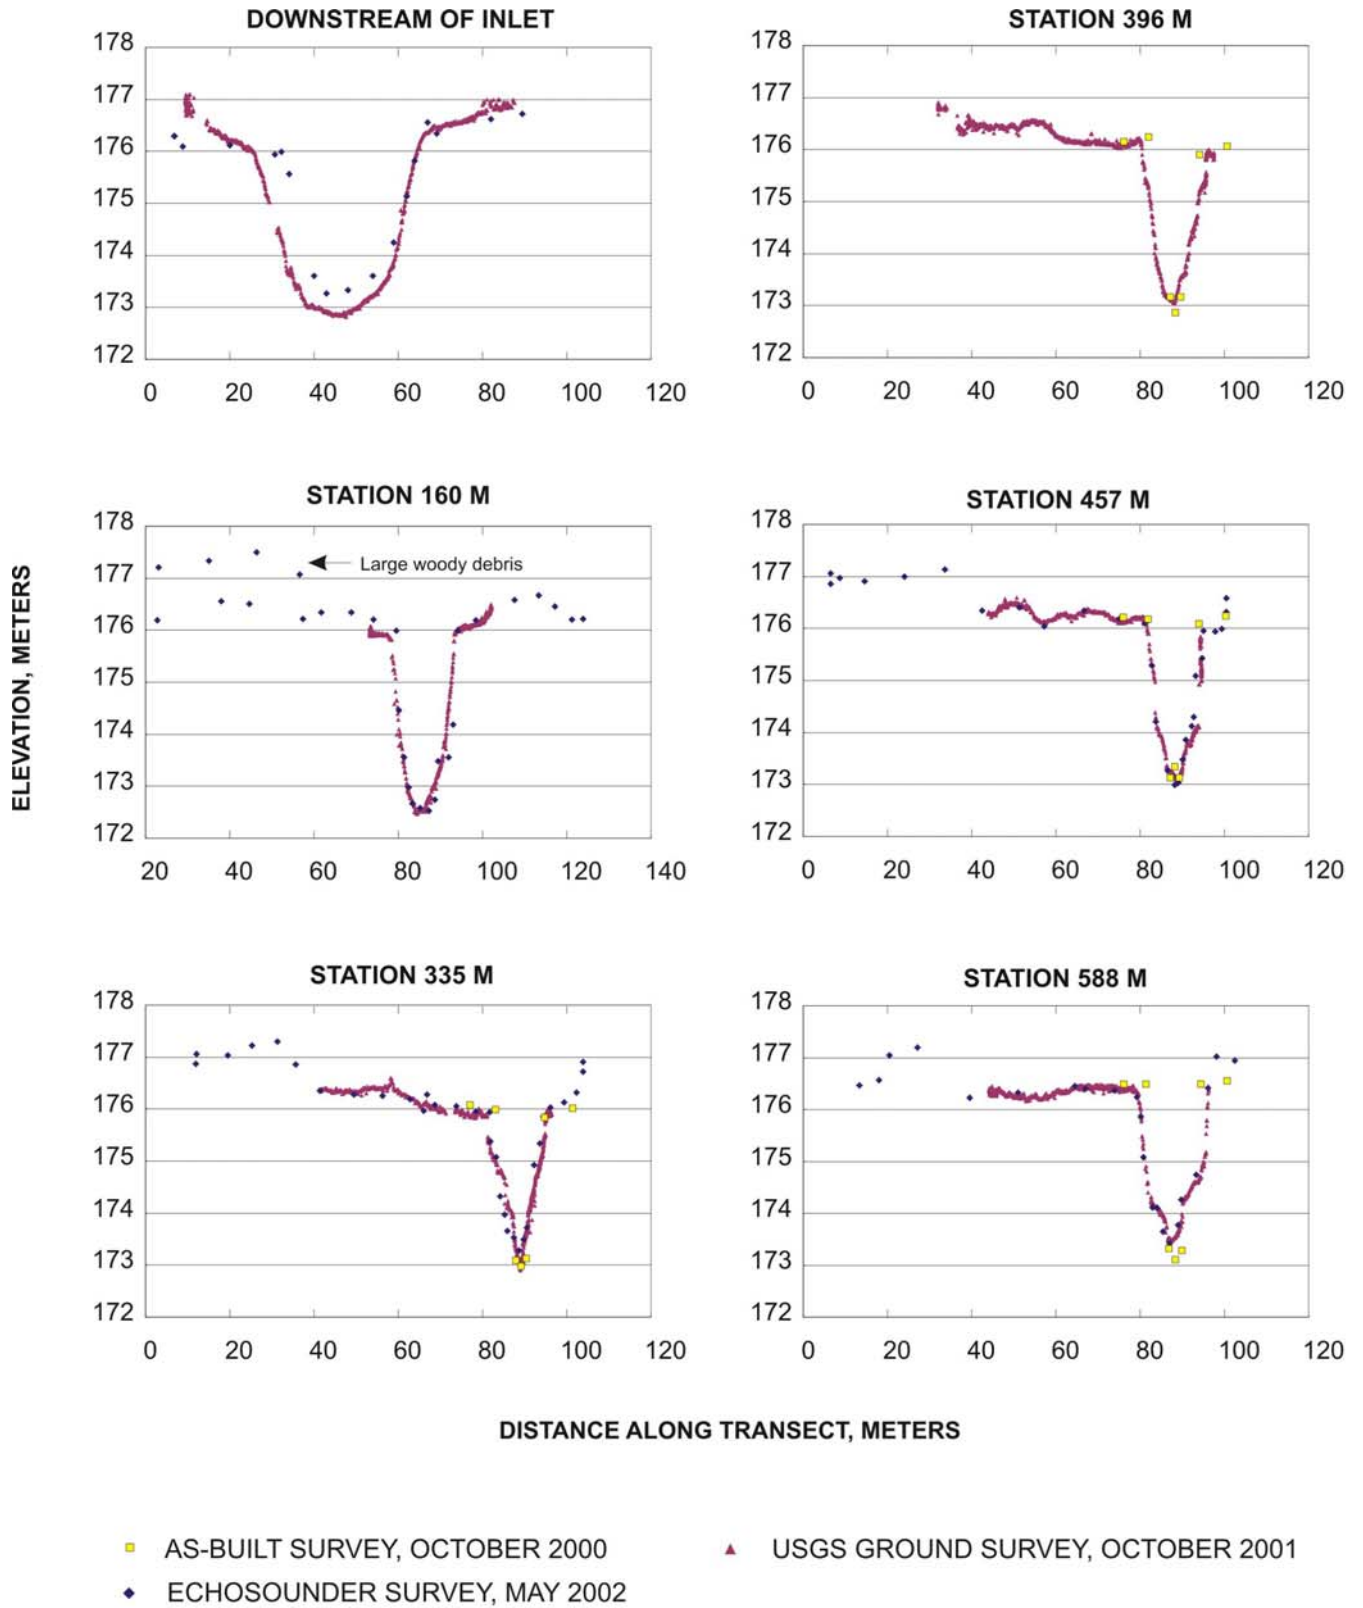
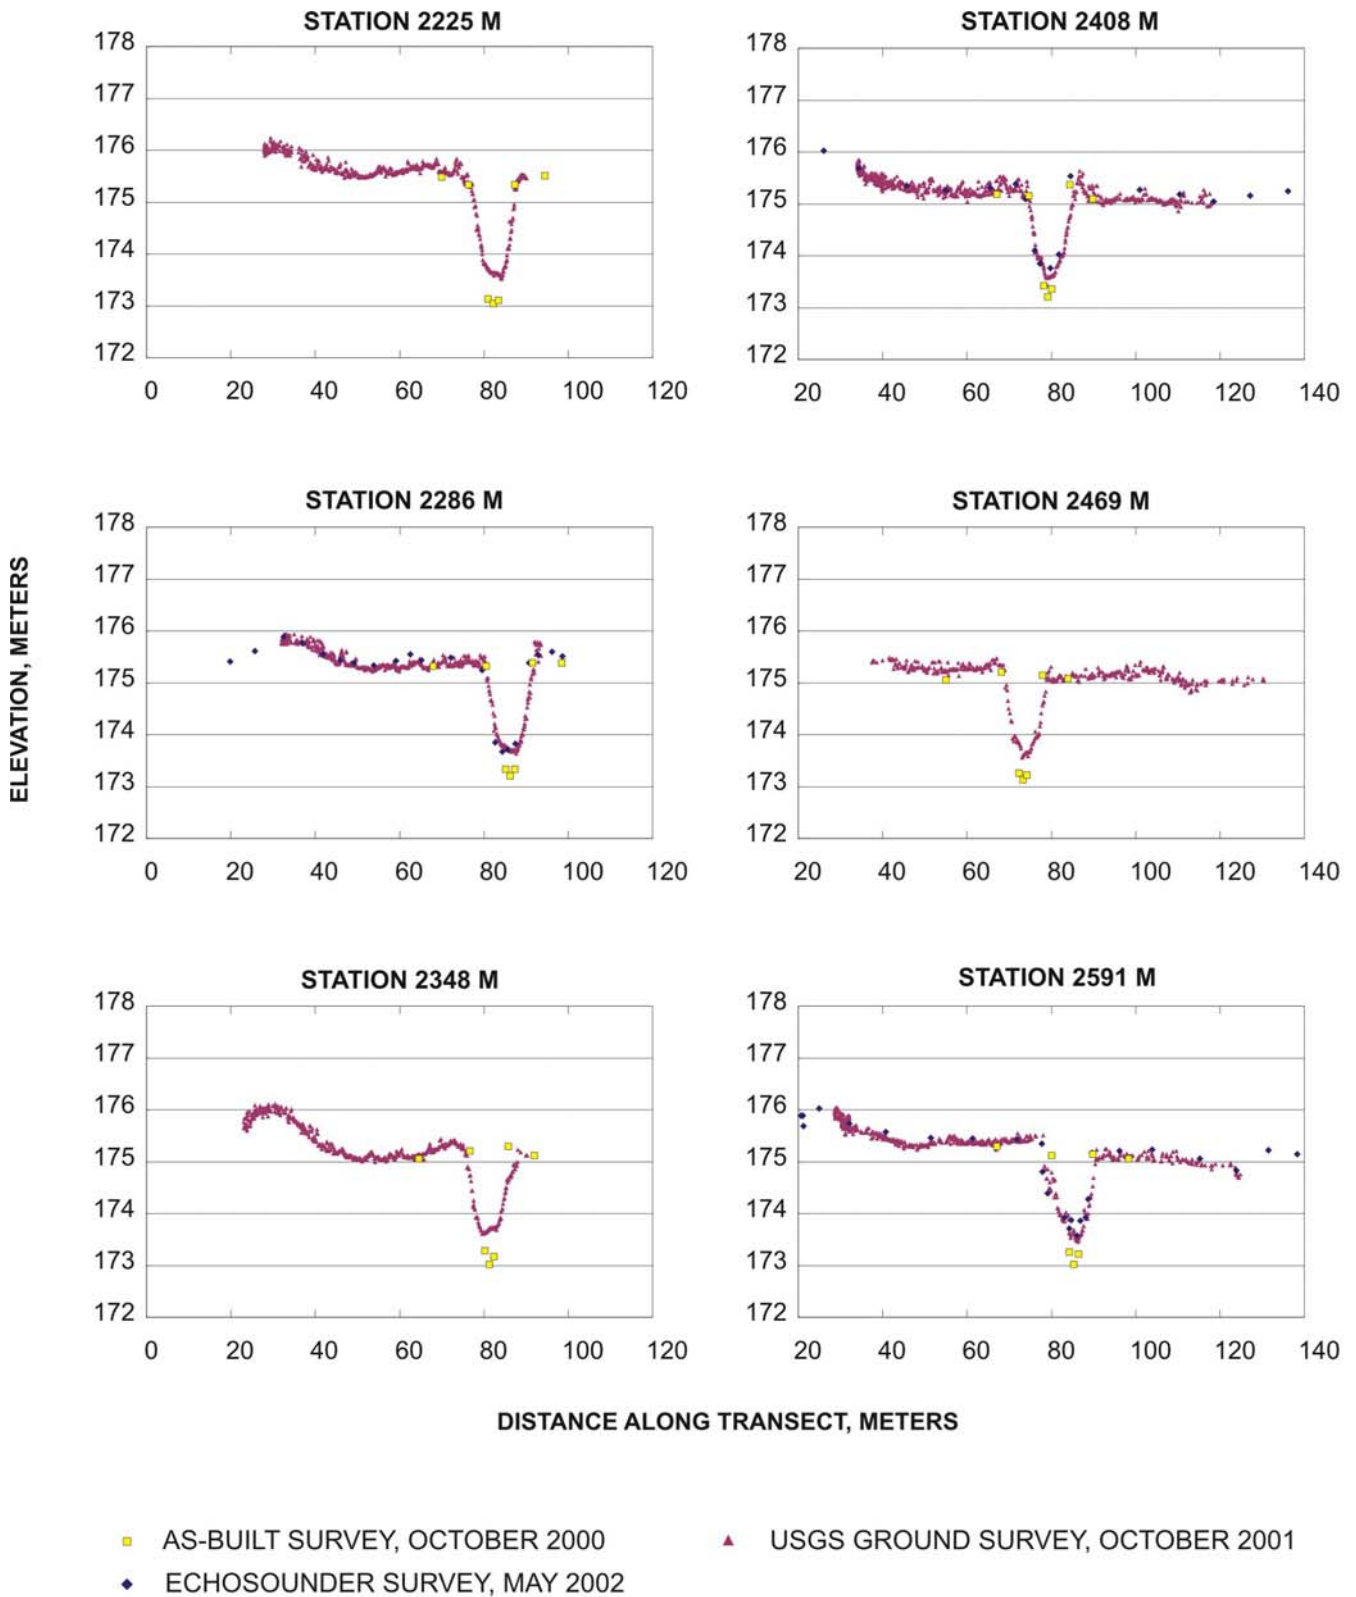
Figure 31. Monitored cross sections in North Overton Bottoms side-channel chute, surveyed October 2000, October 2001, and May 2002.
